# Andrew N Carr BA FRICS

**BUILDING  
SURVEY  
REPORT**

**XXXXXXXX PARK  
SWINDON  
WILTSHIRE**

**(Ref: 90XXX)**

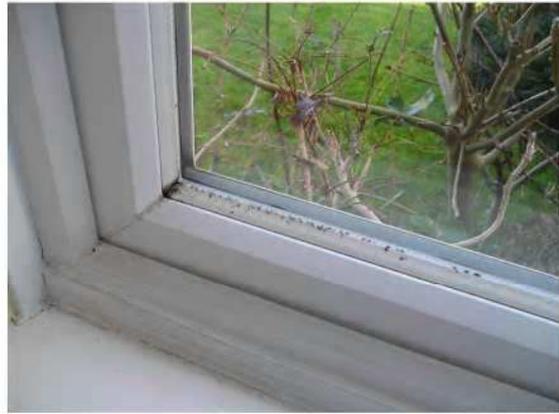
such be fitted, especially to the toilet, which does not have a window. Lack of ventilation is one of the prime causes of condensation but we did not find a serious condensation problem here, although there were traces of condensation mould on the windows and some condensation dampness was measurable to the lower parts of the walls at the corners of the building. Condensation is very much a reflection of life style, and while one occupier may have no problems another might; we suspect that those facilities for ventilation that are present have not been made use of. If it does become more noticeable in future we would recommend that serious consideration be given to the provision of further permanent ventilators in those rooms most affected.

Condensation mould on window

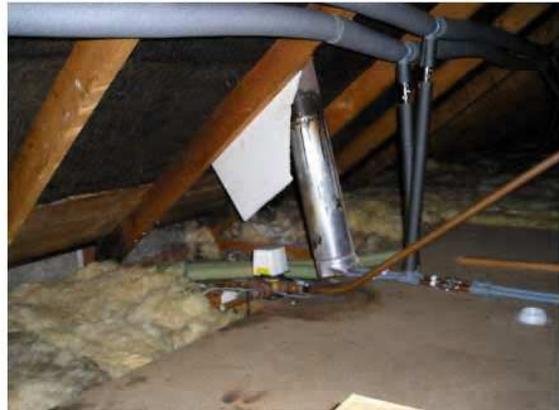
There is a defunct metal flue emerging from the roof not far from the valley: staining on the decking is an indication that rain may be entering under specific weather conditions, but no moisture as measurable. We suggest that this might be removed and the tiling made good. We suspect that the property may once have had a warm air heating system, but do not know this for certain.

Defunct flue

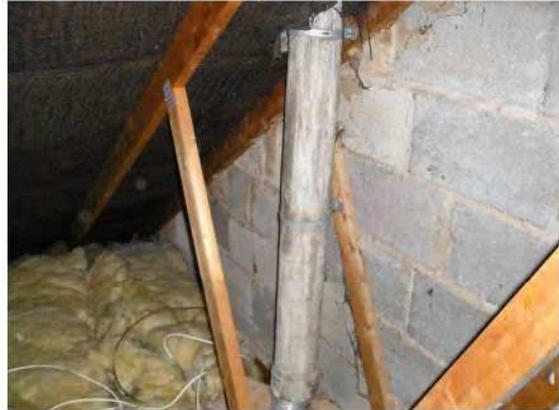
The fireplace in the sitting room is served by a metal flue liner which links to an asbestos cement flue pipe passing through the roof: it is intended to serve a gas appliance. Please see our earlier comments in regard to the material used.

Flue pipe from fireplace in roof

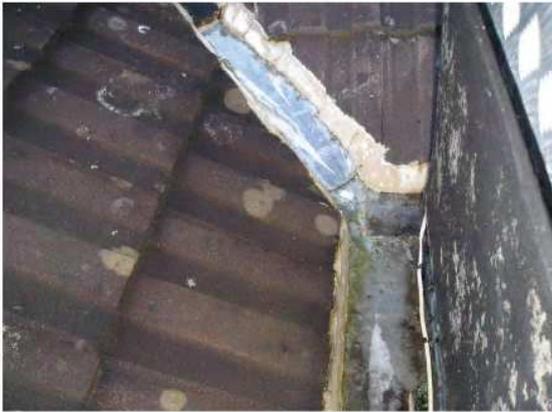
There is an unusual brick "tower" above the toilet with a flat metal capping acting as a roof: the valley between the intersecting slopes of the main roof terminates behind this and there are channels either side of the tower to take the rainwater from the valley. This arrangement is vulnerable to obstruction by debris and vegetation, and laying snow could be trapped leading to water seeping into the roof. There is evidence of past leakage and at the time of inspection there was a small leak close to the foot of the valley, although we were unable to trace its source: further investigation and remedial action is necessary and should not be delayed. We also noted that some of the flashings about the tower are beginning to work loose and these will require some maintenance before very long.

We regard the positioning of this tower as a poorly thought out design feature.

Foot of valley behind tower

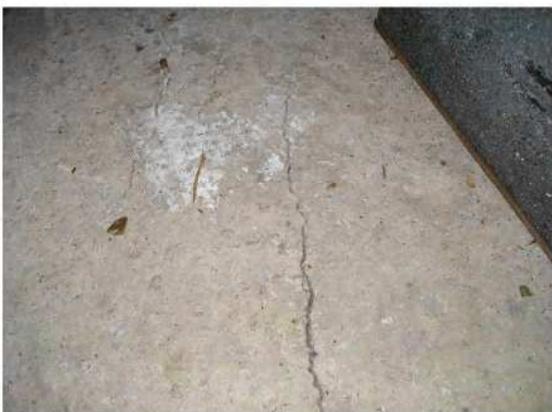
The garage is single and attached, under an extension of the bungalow roof. It is generally in serviceable condition, but we did note quite extensive cracking to the concrete floor. The cracking appears to be of longstanding, but we cannot be certain that it is not continuing. Our suspicion is that the floor is inadequately bedded and/or reinforced to cope with variations in the subsoil resulting from changing temperature and moisture content: this would not be unusual in a building of this age, built before standards were revised after the drought year of 1976. The floor is serviceable at present and we doubt if rapid deterioration will take place, but one should be prepared for the possibility of the floor requiring renewal sometime in the future, with the risk of damage being at its greatest in the event of exceptional weather conditions. We suspect that this could be caused by similar forces to those which have damaged the inspection chamber and drive surface.

Garage floor cracked

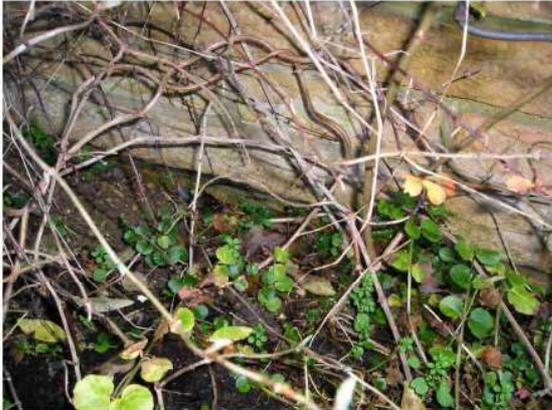
The walling incorporates a conventional damp proof course which, from the lack of extensive dampness measurable internally, is considered to be operating in a satisfactory manner. At present ground level is mostly just below damp proof course level (correctly it should be at least 150mm below) and it is important that this gap is preserved: excessive ground levels are one of the main causes of internal damp problems; the common suggestion that this advice does not apply to modern cavity walled buildings is a fallacy. The desirability of lower ground and path levels should be borne in mind during any future landscaping or paving works and we would have preferred to see a little less vegetation growing against the walling (although this is unlikely to prove problematically in a modern dwelling).

Ground only just under damp proof course

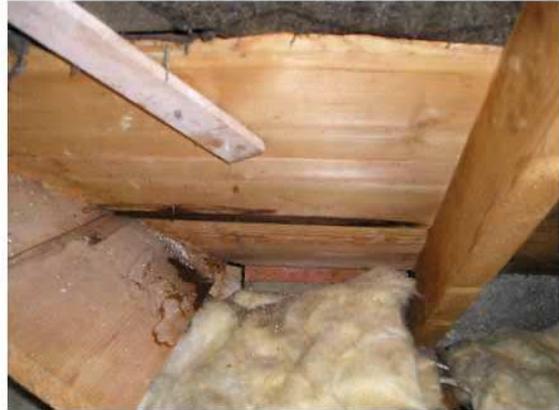
There is some staining to decking and other timbers associated with past plumbing problems, but the only actual moisture found was under the foot of the valley.

No extensive problem of penetrating or rising dampness was found but there is some water ingress associated with the leaking roof valley.

Leak under foot of roof valley

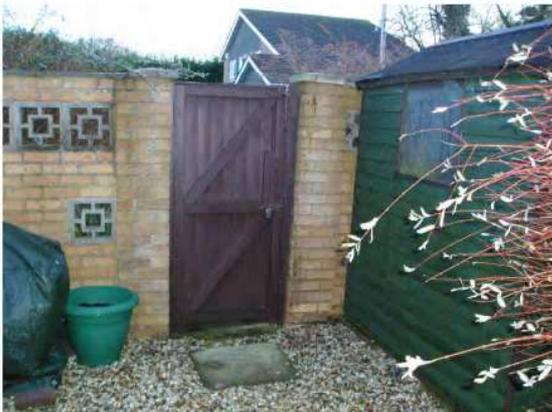
The front garden is open; the rear garden is enclosed by brick walling. The brick and screen block wall to the right of the bungalow is cracked and is unstable: we suspect that it has inadequate foundations for the nature of the subsoil. The wall to the right of the garden is cracked and is unstable in parts, especially towards the rear: this may also have inadequate foundations for the nature of the subsoil, but some of the damage is of a type one would associate with excessive expansion in the masonry. The wall to the rear of the garden is less seriously affected, but is cracked and leaning in places. The wall to the left of the garden is also less seriously affected, although the leaning gate pier is an indication of the movement that has occurred.

Leaning gate pier

We recommend that the garden walling be closely examined to determine which sections need to be rebuilt and which might be salvageable, at least for the time being.

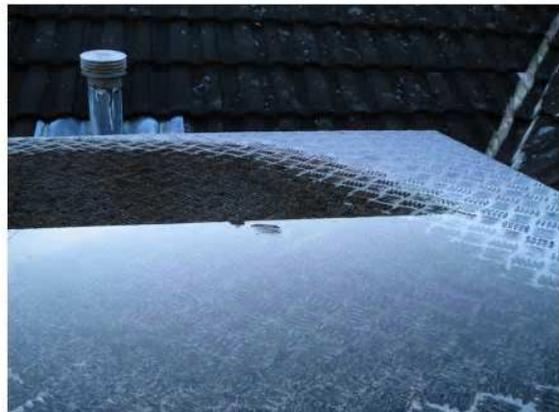
Metal cap to top of tower

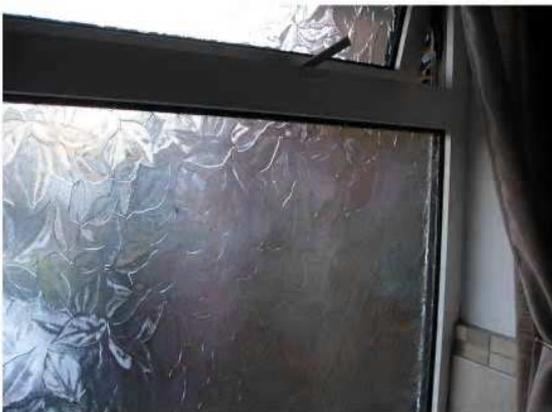
In our experience double glazing does have a finite life expectancy, with misting up as a result of failure of seals often starting to take place when windows are about 15-20 years old; the window in the bathroom is misting up and we suspect that a fanlight in the kitchen may be beginning to do so, possible precursors of failure elsewhere.

Misted glazing in bathroom

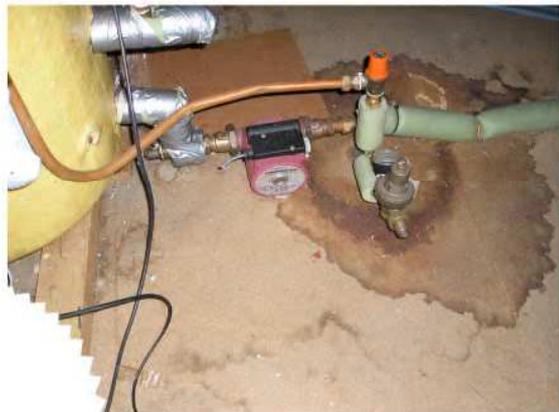
Old staining in roof, now dry

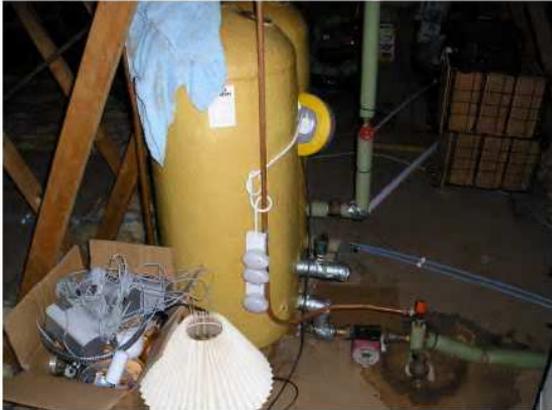
Old water cylinders in roof

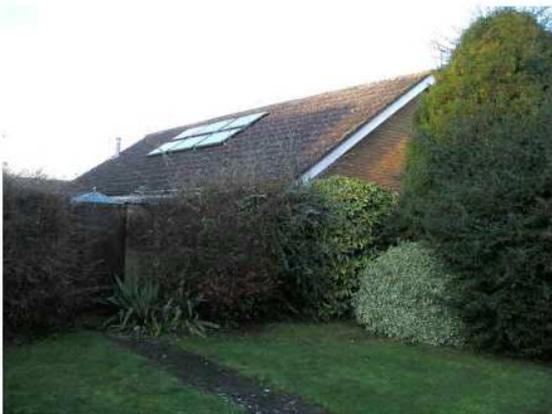
There are a number of solar water heating panels on the rear slope, but these are disconnected and are of significant age: they are unlikely to be to modern standards of efficiency and we have doubts as to their serviceability, especially as early systems often incorporated perishable components. Within the roofspace there are various pipes and cylinders associated with the panels, but these are also disconnected and clearly old; there are also redundant pipes and tanks associated with the normal plumbing. If you are considering resurrecting the solar system, then specialist advice should be sought.

Rear slope of roof

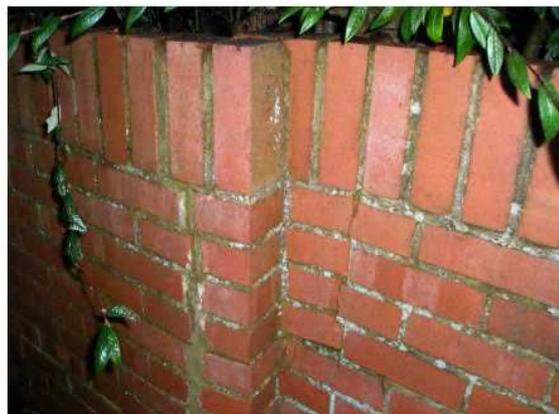
Right garden wall cracked, twisted and unstable

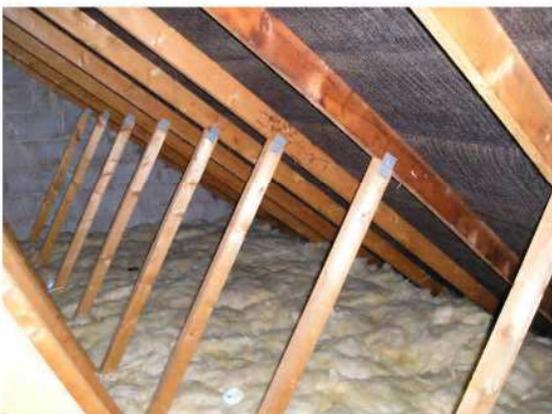
The main roof structure is a typical modern framework of prefabricated trussed rafters but is an early version lacking diagonal and lateral wind bracing and without the metal restraint straps to the gables which would be fitted today. While the structure may not be to latest standards, it is typical for its age and type and might fairly be described as having withstood the test of time: there is only very minor distortion and very slight displacement at connecting plates. We would not have considered reinforcement essential, but this is a matter of opinion and even after all these years a mortgage valuer may still call for the installation of some additional bracing (fortunately not a very complicated or expensive operation). We would advise against overloading the roof structure in any way: the roofspace is not designed to take heavy weights (few are) and while light storage should be acceptable, excess use could cause cracking to the ceilings (it is possible that the heavily textured finish may serve to conceal earlier superficial cracking).

Roof trusses lack wind bracing

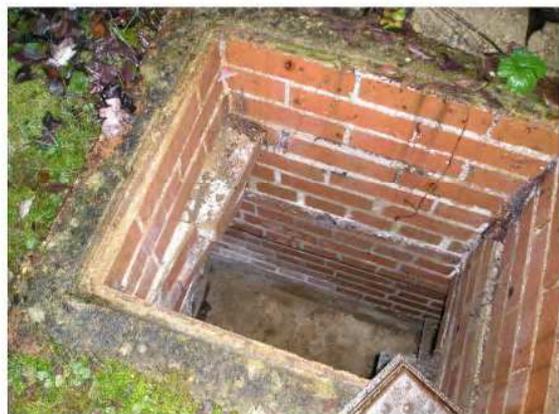
Brickwork at the top of the second chamber is displaced, damage similar to that which sometimes occurs when subsoils expand when wet or frozen, or when pressure is imposed by tree roots; the risks are greatest on clay subsoils, with movement occurring either in the clay itself or in water logged soil above the clay. Some localized repair is necessary and until proven otherwise it would be prudent to assume that the other chamber may also require attention. The lids to both chambers are corroded and the lid frames no longer properly retained by cement fillets; we suggest that both lids be renewed.

Second inspection chamber brickwork displaced

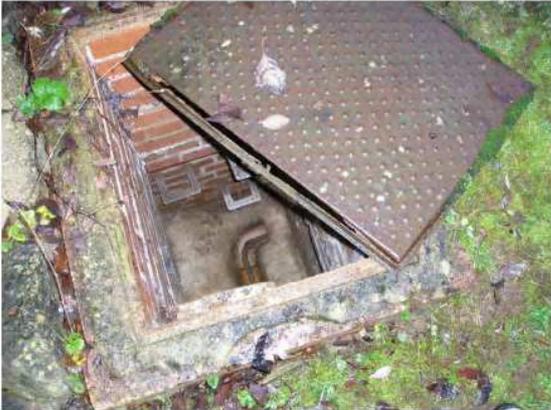
Second inspection chamber lid corroded and loose

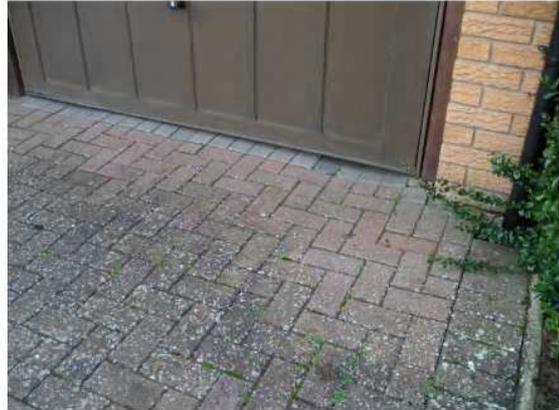
The pavior drive at the front is uneven in places and we suspect that some ponding will occur in wet conditions: it must be said that while disappointing, this is not particularly unusual, especially over clay containing subsoils.

Uneven drive surface

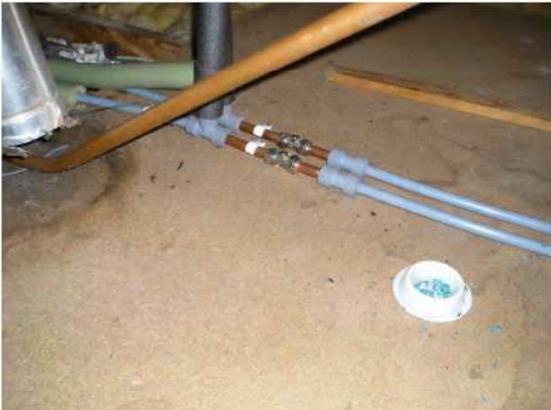
There is evidence of the presence of rodents in the roof. This is hardly unusual, but because of the tendency for rodents (including squirrels) to gnaw electric cabling, it is important that they are properly controlled.

Some of the pipework in the roofspace is lagged but there are gaps and some sections of the central heating pipework are not insulated at all: this is thermally inefficient and increases the risk of freezing should the heating be left off (or fail) in icy conditions. There is now a move towards insulating all hot water pipes throughout the building (to conserve energy) although one would not normally attempt this in an existing building except where pipes are easily accessible.

Unlagged pipes and rodent bait

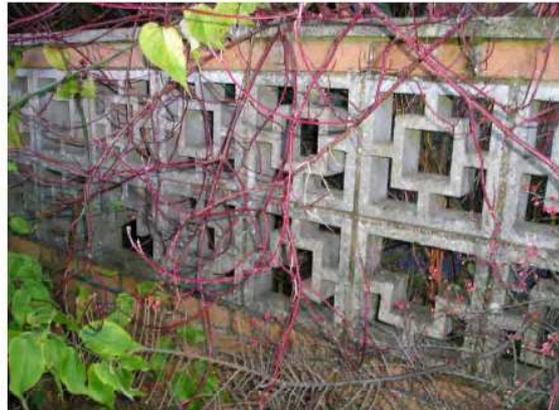
Unstable screen block wall to right of bungalow

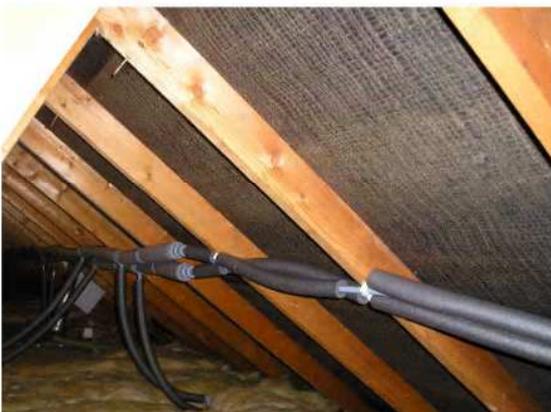
Unusual central heating installation

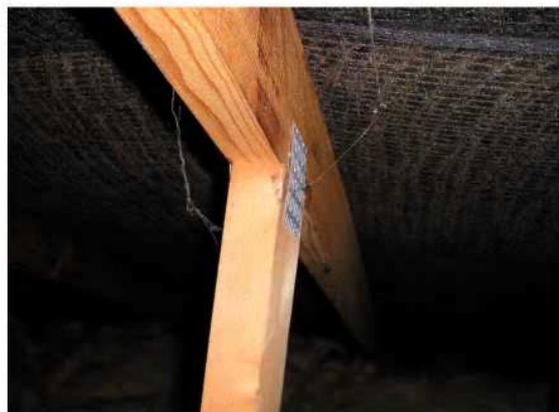
Very slight connecting plate displacement
