**BUILDING
SURVEY
REPORT**

**XXXXX FARM
THE STREET
XXXXXXX
WILTSHIRE**

7th December 2010

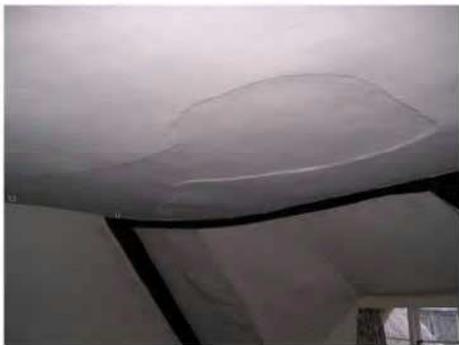
The ceilings show evidence of distortion, cracking and hollowness, and there are many areas of plaster that are weak even by the standards of a house of this age: the sloping ceilings are particularly weak (including to the kitchen) and have partially collapsed in the bathroom and on the rear landing; the scullery ceiling has been badly weakened by a leak from above; the ceiling to bedroom 3 has been patched but remains very weak. The ceilings (particularly those mentioned above) are vulnerable and fragile and failure could easily be precipitated by impact or dampening.

Ceiling in bedroom 3

Our normal recommendation would be to retain old plaster (which forms an integral part of the character of a building of this age) for as long as possible, repairing as and when necessary; the conservation officer would certainly wish for historic plaster to be retained wherever possible. We are, however, concerned that in this case some of the plaster is sufficiently unstable that it could fail without notice and damage anything delicate that may be below. There is no reason why these ceilings could not be repaired with lath and plaster.

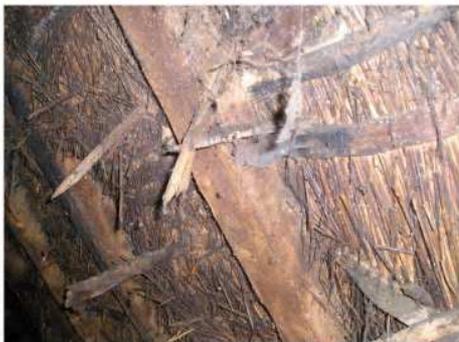
Damaged battens

At present there is no visible immediate need for repair, although we suspect that removal of distorted plaster to the rear of bedroom 2 may reveal a snapped rafter. There is quite widespread failure of battens we recommend that these be replaced prior to re-thatching: this is a normal maintenance requirement.

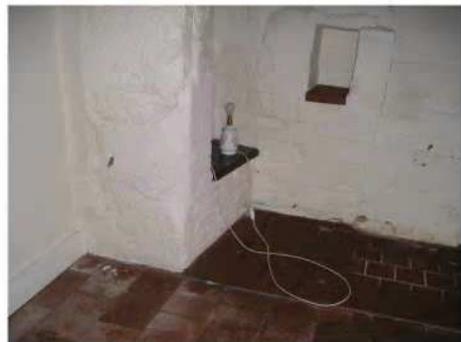
There is dampness at the feet of the stacks. This is only to be expected and is likely to be the usual combination of rising damp, moisture penetrating down from above and chemical contamination, not helped by the masonry being painted with impermeable paint. We would normally advise that the masonry be left exposed and the property kept well ventilated, in order that any such moisture may disperse; alternatively we would recommend the use of a lime based plaster and lime wash finish (although there may be hidden modern materials which would be incompatible with this). Chalkstone is particularly unsuitable to be painted over and from the description given it was probably unpainted at the time of the listing.

Damp to fireplace in family room

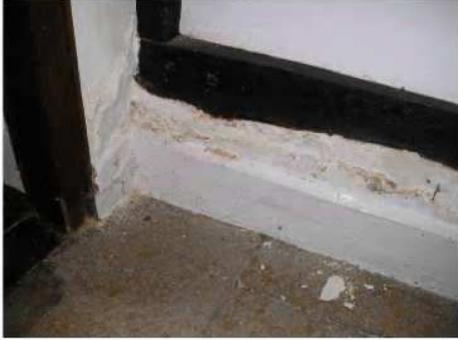
Damp under and to soleplate in hallway

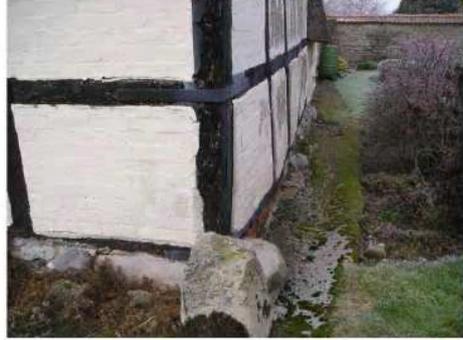
There is a problem to the right of the sitting room where the soleplate has decayed, leading to outward movement of the wall at low level and some displacement and loosening of the lower panels. The decay is likely to have been exacerbated by covering the soleplate internally by lining the wall, and externally by a rubble fillet and (in places) by render: even when damp, soleplates can be surprisingly durable if left exposed and able to "breathe". To the front of the wall, where the distortion is worst, it appears that the sarsen footings have been replaced with brick: possibly at one time there was a doorway or drain here. In our opinion the damage is sufficient to warrant reconstruction of the lowest part of the walling here (up to the first horizontal timber), to include renewal of the soleplate and possibly the lowest parts of the uprights: however the conservation officer will have an opinion on the extent of works needed and their nature.

Displaced walling to right of sitting room

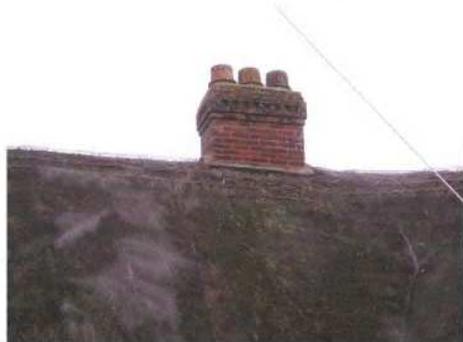
The thatch is showing general evidence of wear but, with some localized attention, we believe that that to the main slopes should remain serviceable for several years yet; there is still a good overhang at eaves. The ridge will require early attention as will some of the more vulnerable locations, such as at the stacks and valley. The valley to the rear left is quite sharply formed and has therefore been lined, rather than finished with swept thatch; the lining is some form of felt and is now in quite poor condition and in need of early renewal.

Front stack and wear to ridge

Thatch is a specialist matter and in view of the condition of the thatch we must recommend that you take further advice and obtain estimates of likely future expenditure; in our experience advice and estimates can vary tremendously from one thatcher to another and we would normally recommend the employment of an established local thatcher of good repute. The best thatchers tend to have long waiting lists, not uncommonly a year or more.

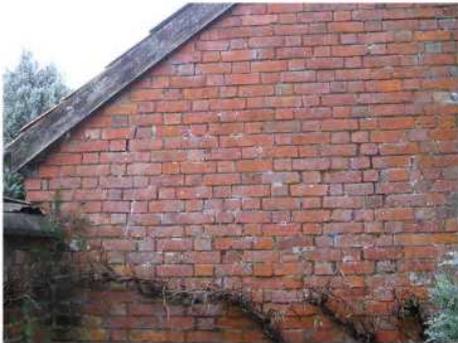
Garage gable wall pointing poor

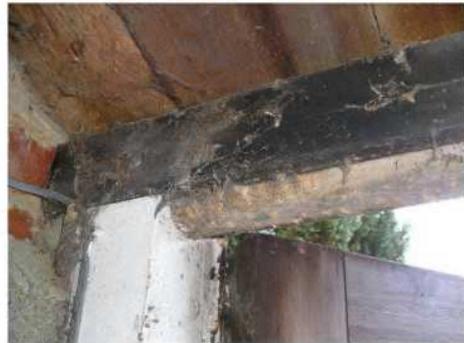
Garage wood boring beetle activity

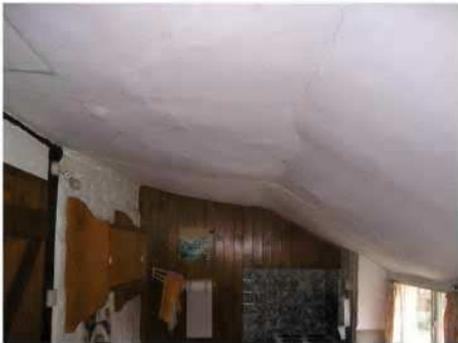
Kitchen ceiling

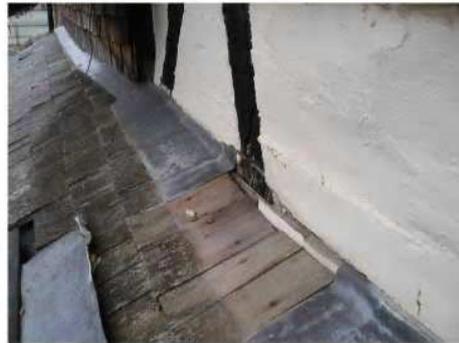
Porch flashing slipped

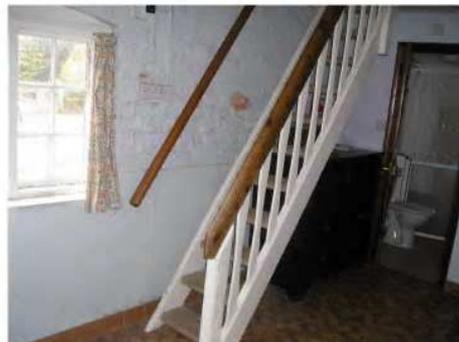
The staircases are free from evidence of any serious weakness or failure, but are below current safety standards, particularly the rear staircase.

Rear staircase and damp walling

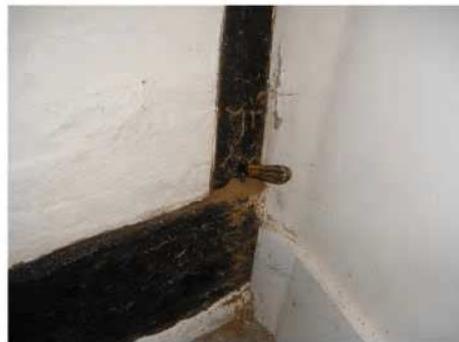
Dampness in places is sufficient to place low level timbers at risk: in addition to the "usual" softening by rot to skirtings, we noted some rot to low level joinery (including the door frame to the sitting room) and to partition framing (especially the partition between the family room and the lobby behind). The lowest parts of the wall framing, particularly the soleplates, are obviously at risk, although if exposed and able to "breathe" decay to these can be extremely slow: we are concerned in regard to the hidden sections of such timbers and those where plaster and paint lap over them, such as to the right of the dining room.

Rot to partition between dining room and lobby

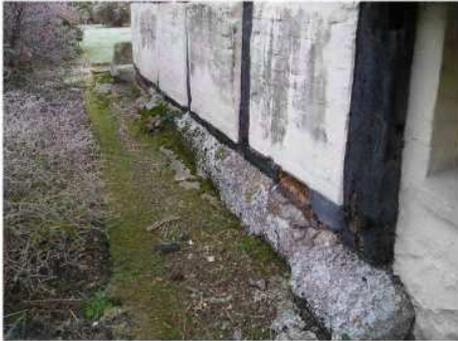
Rot to soleplate to right of sitting room

- Early attention is recommended to decayed lower frame timbers (particularly soleplates) to front and right together with some reconstruction of the lowest masonry here.

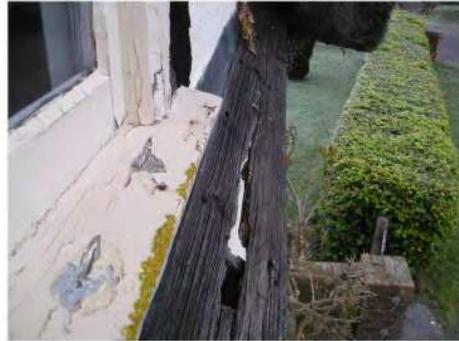
Rot to window cill and pent roof

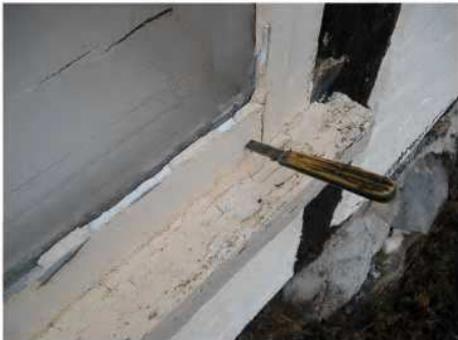
As one might expect, there is a certain amount of decay by wet rot to the external joinery and some repair will be needed prior to next and subsequent redecorations. The worst decay we found was to the windows to the family room, sitting room, scullery and bathroom, and to the pent roof that has been fitted at about first floor level to protect the windows below, but most timbers have decayed to some degree. Repair, rather than renewal, is still a realistic proposition, particularly as, in our experience, older joinery tends to decay more slowly than that employed in more recent times. We suspect that the conservation officer would resist any suggestion that windows be renewed (although windows are not original) and it is likely to be necessary to continue on a repair “as and when necessary” basis for the foreseeable future. If this were not a listed building then one would be considering renewal to reduce future maintenance costs and to improve thermal efficiency.

Rot to window timber

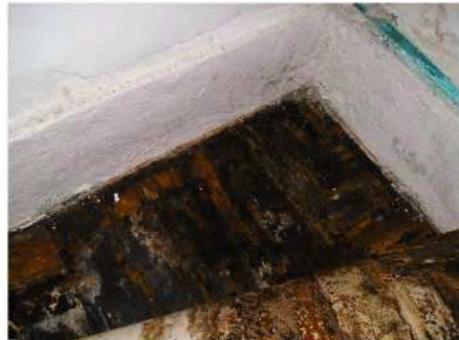
Rot to wood block floor in dining room

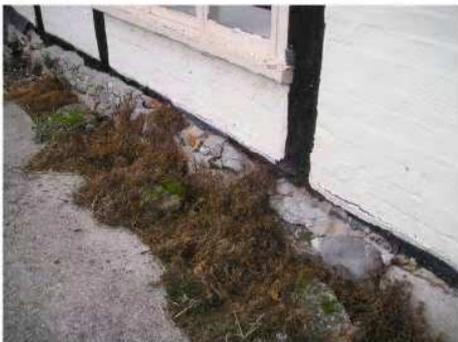
Ground level about parts of the property is close to or above floor and normal damp proof course level, rather than the 150mm below that is now recommended: too much of the older part rubble and mortar fillets are effectively raising ground level to soleplate level and bridging the relatively moisture resistant sarsen footings. At the rear path level is well above the floor level of the Victorian part of the building. High ground levels increase the risk of internal dampness and it is desirable to keep ground levels low and vegetation under control. While there may be practical difficulties to comprehensive ground level reduction, we would certainly recommend this where possible and would advise the removal of bridging fillets and render.

Rubble fillet to front of sitting room

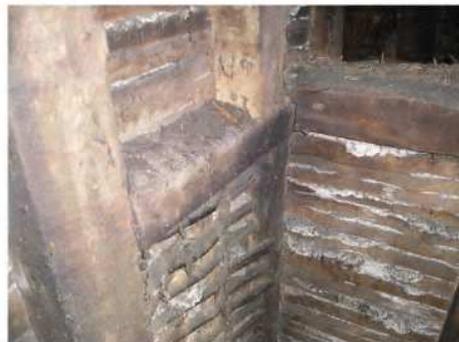
There is smoke/scorch marking to timbers towards the rear of the house, and on some of the plasterwork visible in the roofspace: we suspect that this is fire damage rather than cooking smoke, as the chimneystack is very old, probably original.

Scorching to wattle and daub

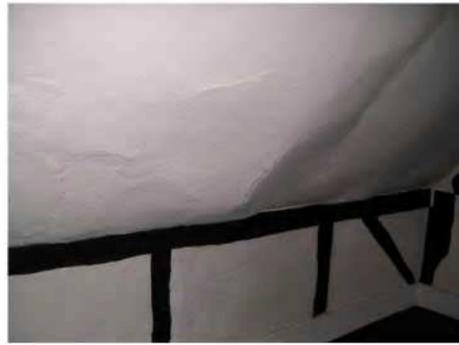
Suspected snapped rafter behind bedroom 2

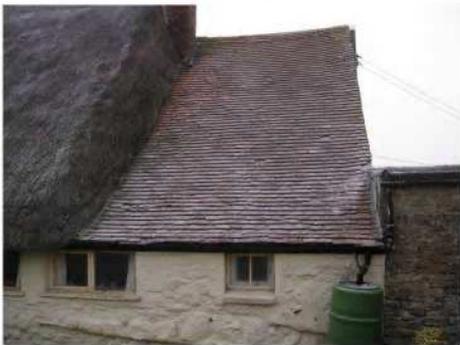
The tiling is deteriorating, particularly to the right slope, with cracking, crumbling, lamination and increased porosity; however at present only a handful of tiles require immediate renewal and we would have considered comprehensive re-tiling (even if permitted by the conservation officer) to be premature as it should be possible to continue on a repair "as and when necessary" basis for the foreseeable future.

Tiling deteriorating, especially to right

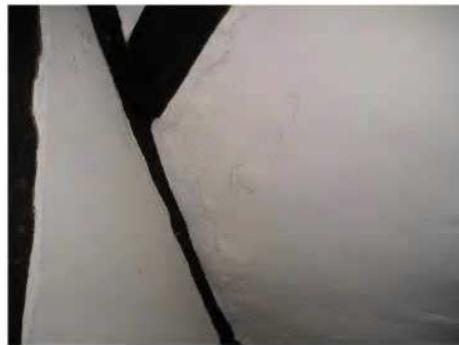
Very hollow plaster to sloping ceiling

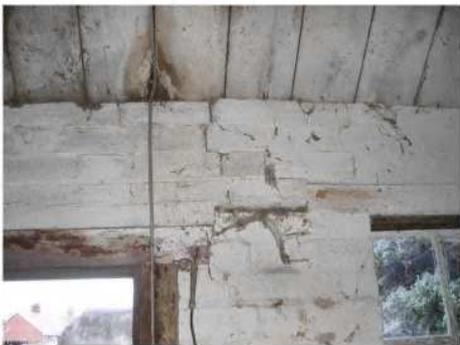
Wall distorted over workshop door

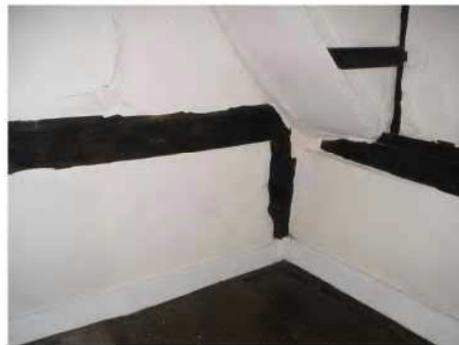
A-frame roofs tend to push outwards on the upper parts of the walling, leading to what is known as roofspread: this has occurred here and can most clearly be seen to the right of the front elevation and to the left of the tiled roof. In the former location the combination of stress from the roof and a failed frame joint has led to the wallplate rotating and the upper part of the front wall leaning out: to counter this, metal strapping has been fitted around the corner and the indications are that this work has restored stability.

Wallplate displaced to front right of bedroom 2

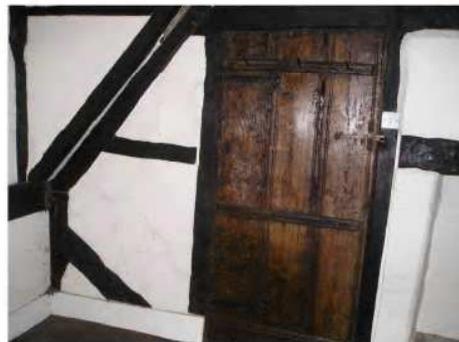
Internal doors mostly open and close reasonably well, having regard to the fact that this is an old building. There is some wear and tear to the doors and some are of considerable age, especially to the first floor.

Wear and tear to old doors
